# LASER PROFILING AND IT'S USE IN PIPE ASSESSMENT AND REHABILITATION

Rob Lee, P.E.  
Brown and Caldwell

# CCTV vs Profiling

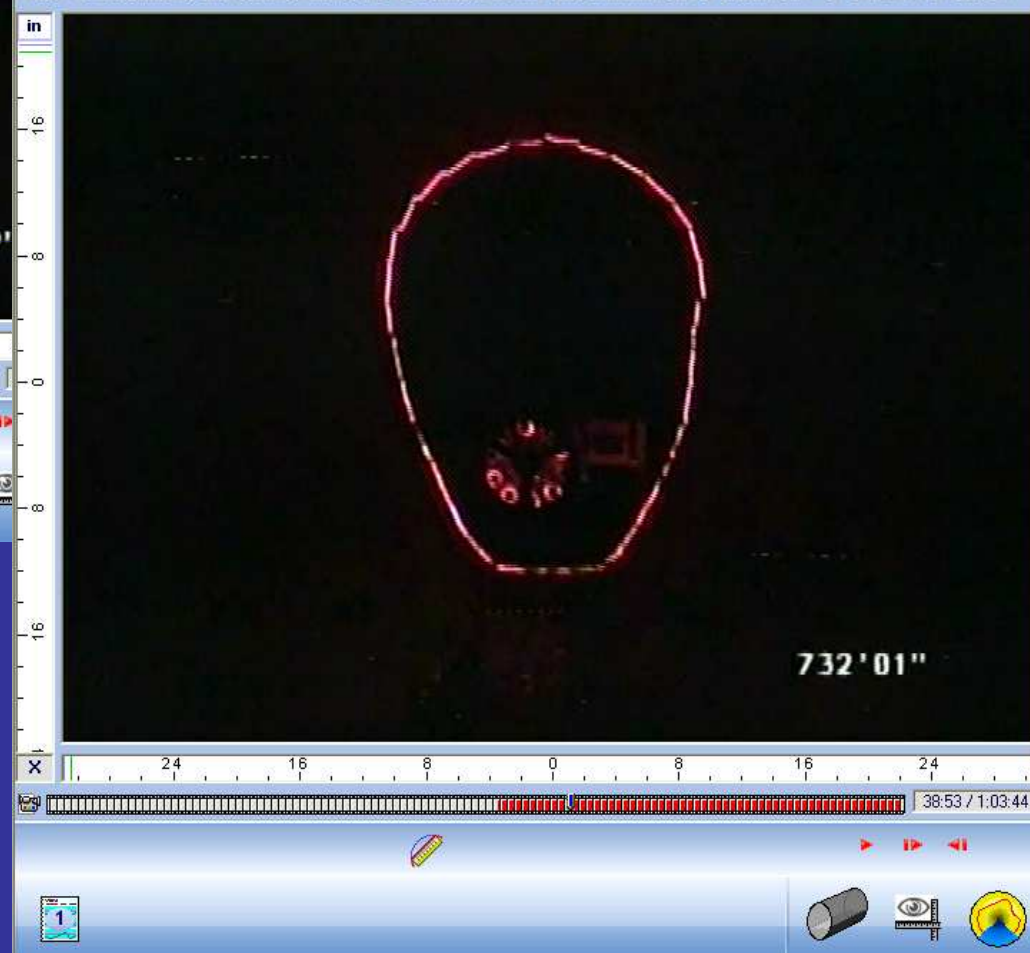
Circumference varied from  
74.5 inches to 78.6 inches

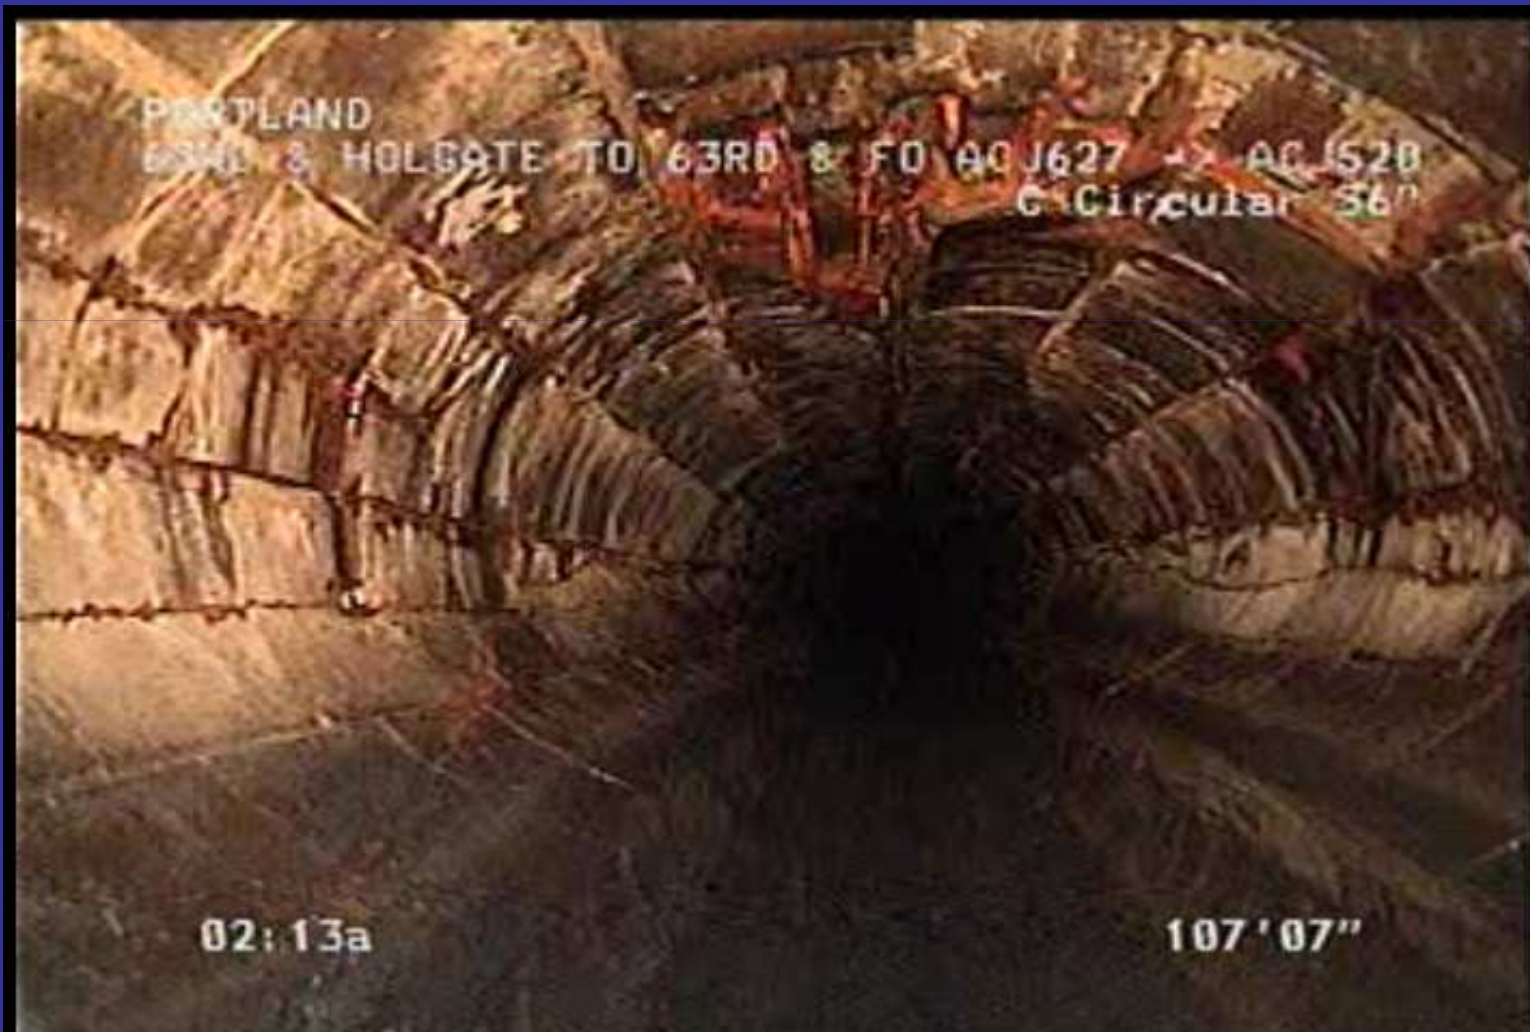
# ACJ627 to ACJ520 Hole at Crown @ Sta. 1+10

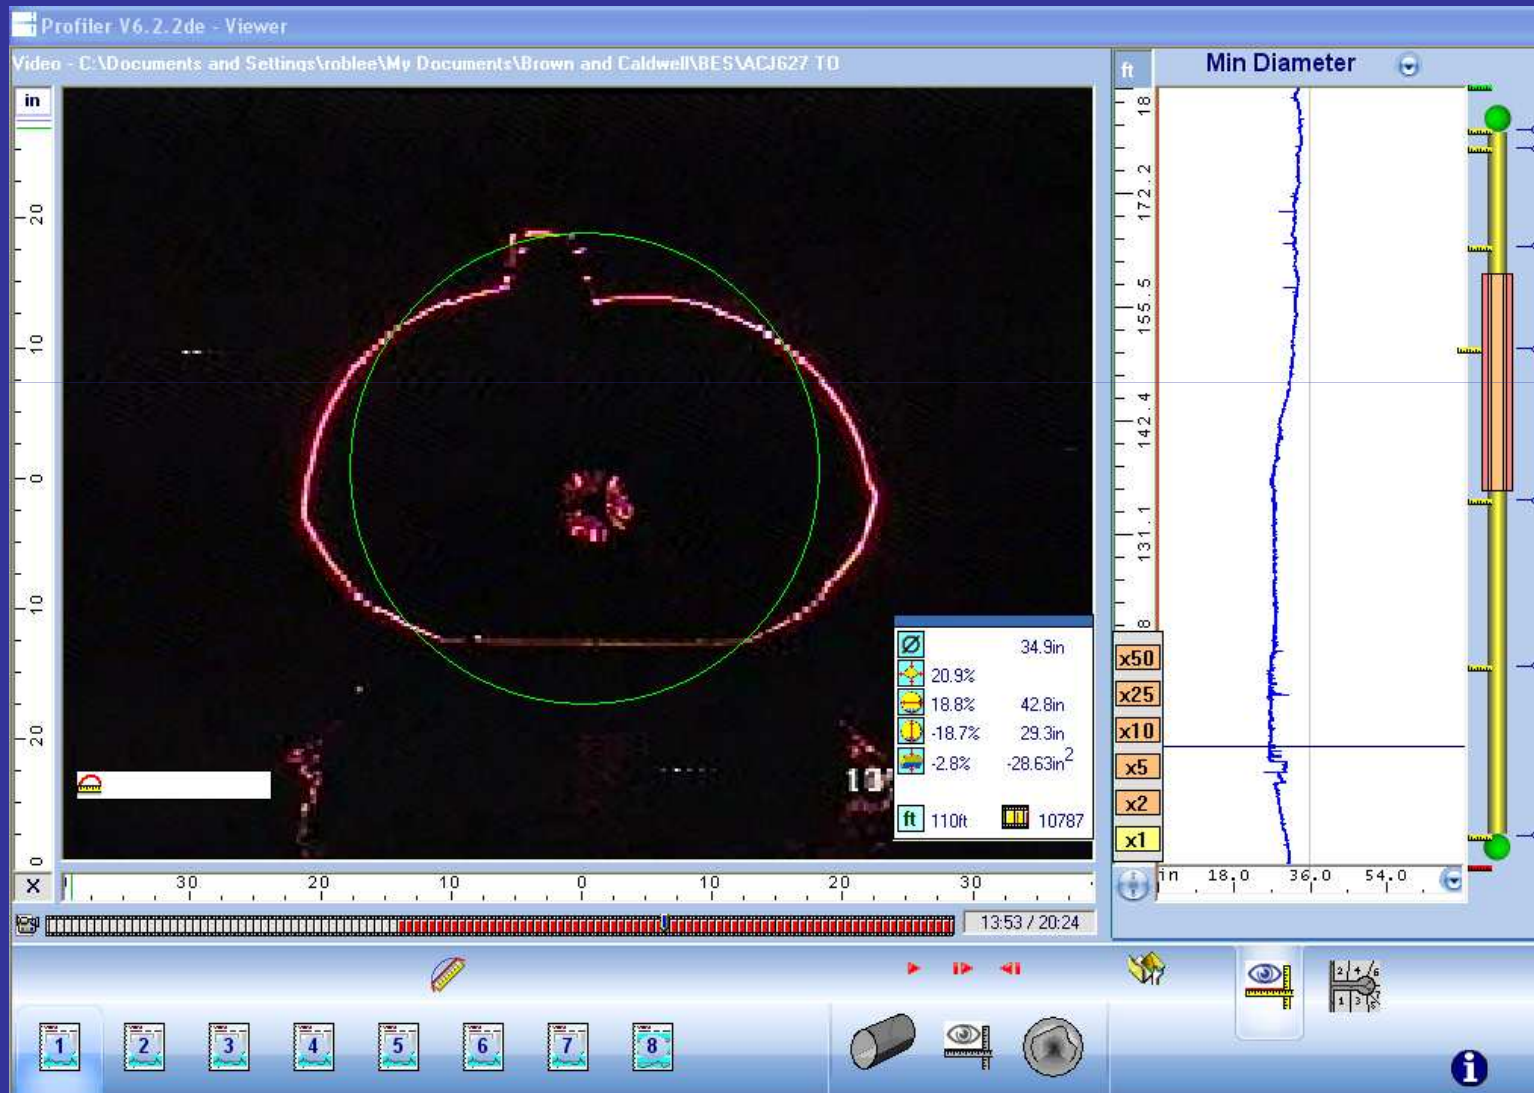
# ACJ627 to ACJ520

## Hole at Crown @ Sta. 1+10

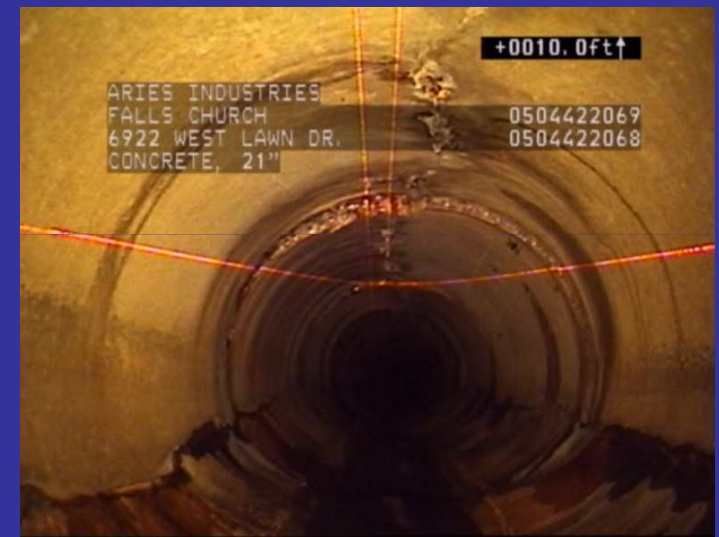
# Structurally Compromised Pipe

- Trenchless Repair Preferred
- Existing IDQ with CIPP Contractor
- “On-screen” measurements revealed number of sections with ovality > 10%

# CIPP Design

- ASTM F1216 limits design to circular pipes
- Used WRc Type II design for non-circular pipe (oval)
- Assume fully deteriorated (added soil and live loads to design head)
- 22.5mm thickness
- Installation and hydraulic concerns with thickness 1" thickness for 21" pipe
- Needed true ovality...

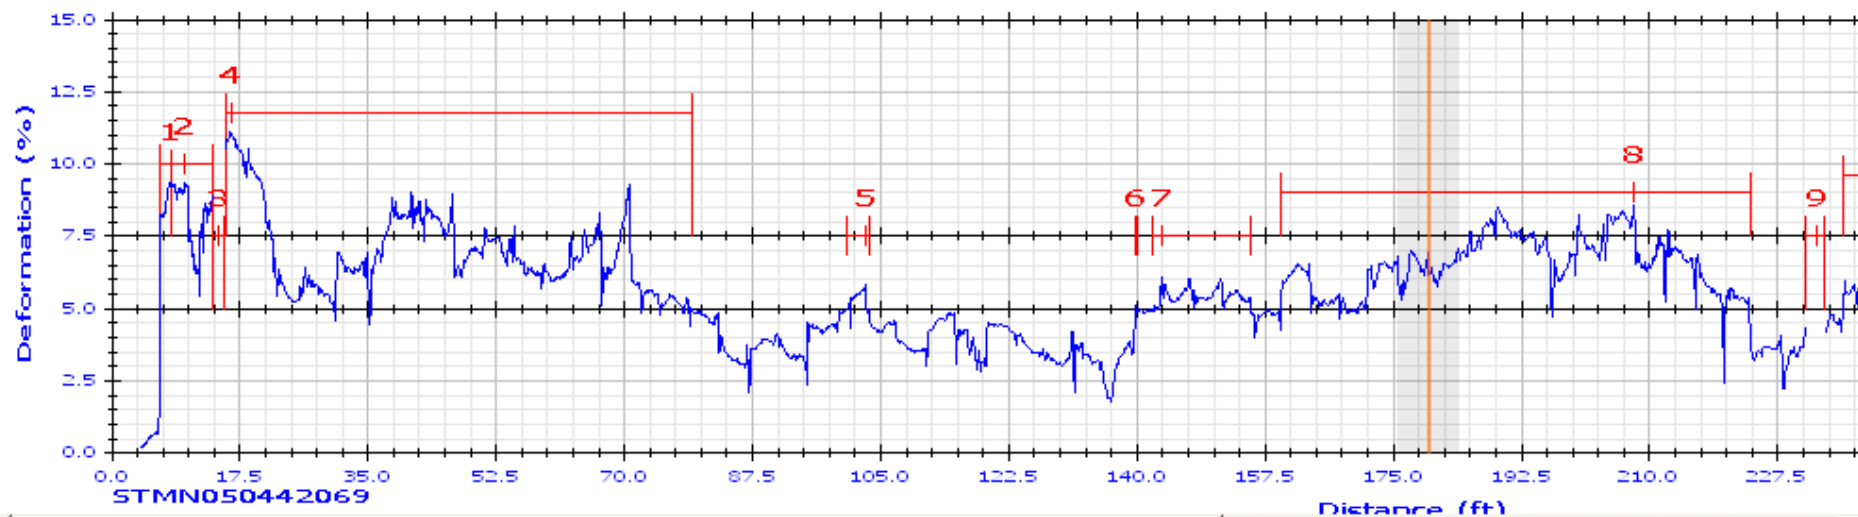
- 4-foot section with ovality  $> 10\%$  (11.5%)
- Next worst is 9.5% (error is  $\pm 0.25\%$ )
- Fully segmental CIPP = 15.0 mm (per F1216-07b)
- Worst section structurally reinforced with cured-in-place point repair prior to full CIPP
- Win-Win-Win Situation

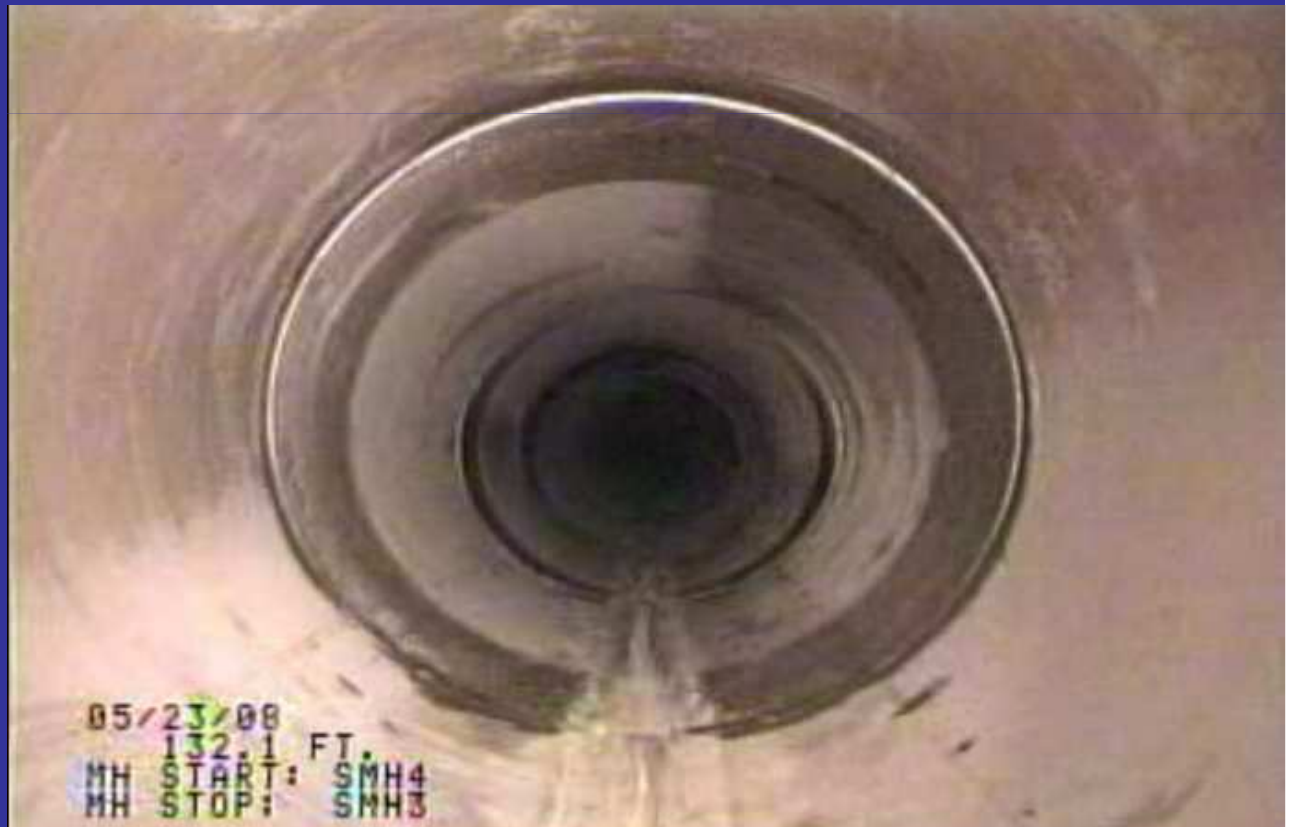
# Actual Deflection

- First two segments overly deflected
- Hand Measurements = 5%

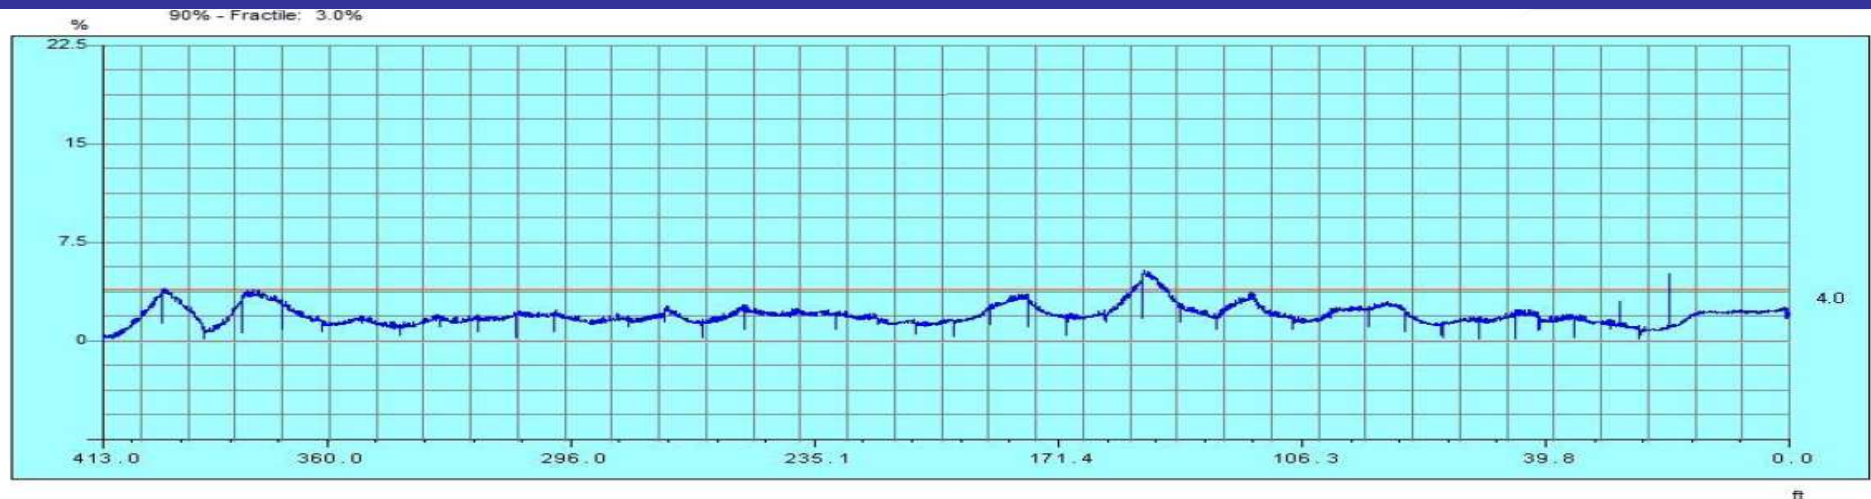
- 5.5% at worst location
- Reprofilng required at warranty inspections (2-years past Substantial Completion)
- Sections greater than 6% will need structural enhancement (i.e., CIPP) at no cost to Owner
