# Pacific Northwest Clean Water Association

## Tale of Two Screens

*John Koch*  
*Ben McConkey*

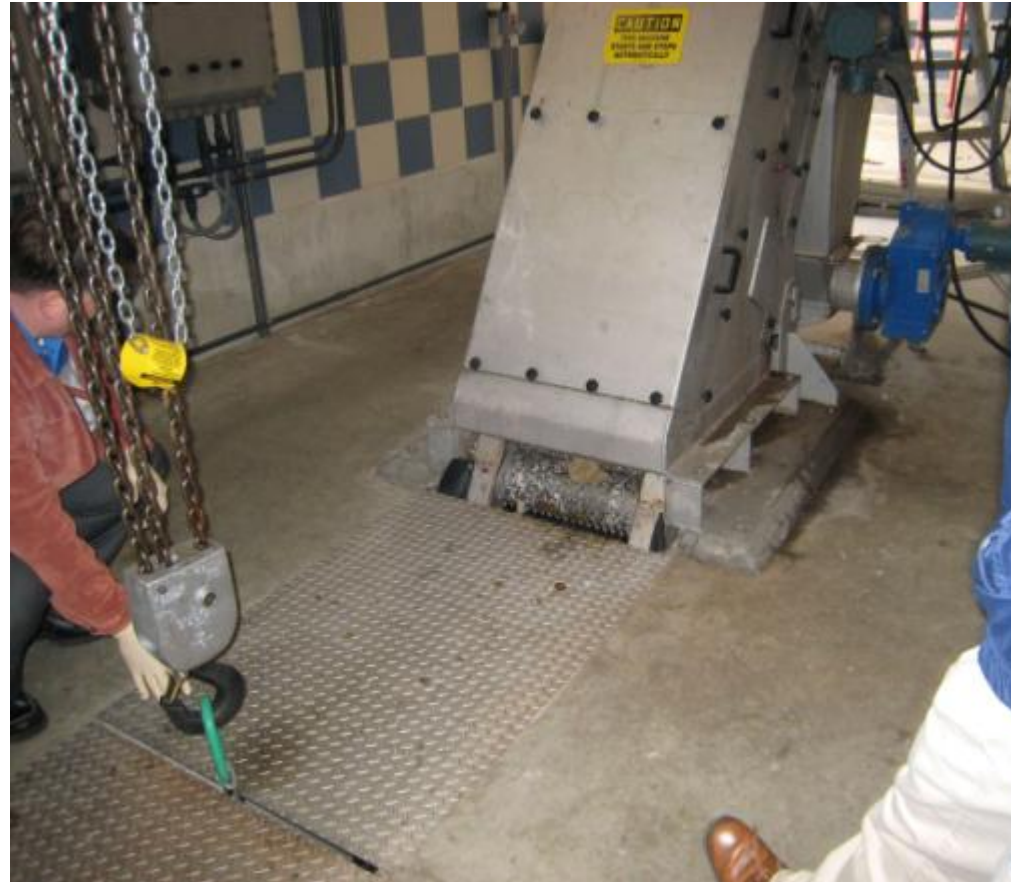
# First Barrier In the Treatment Process

- Influent Screen
- 3 mm Perforated Plate
- Water Spray and Brush Cleaning

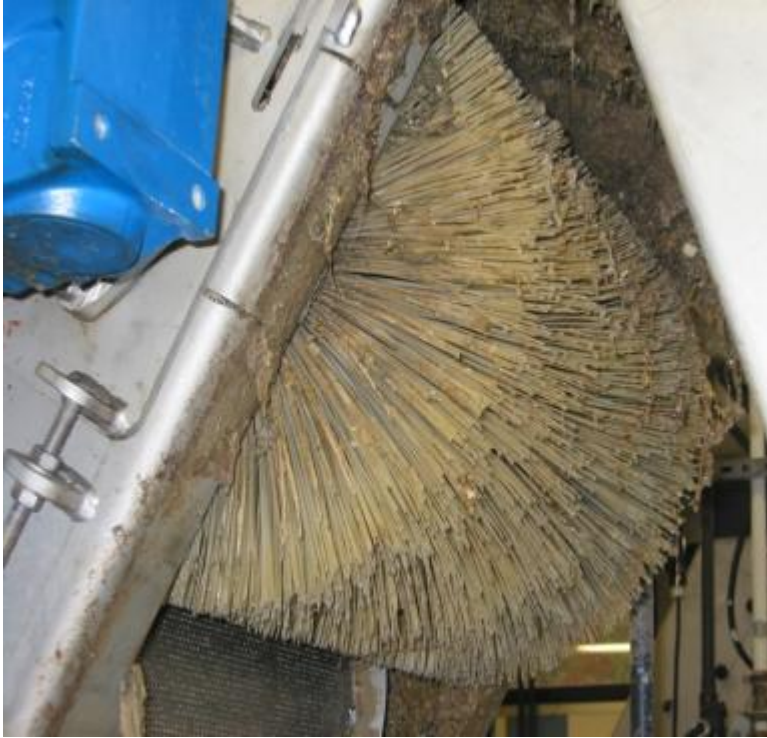
# Cleaning Mechanism

**Brush and Water Spray**

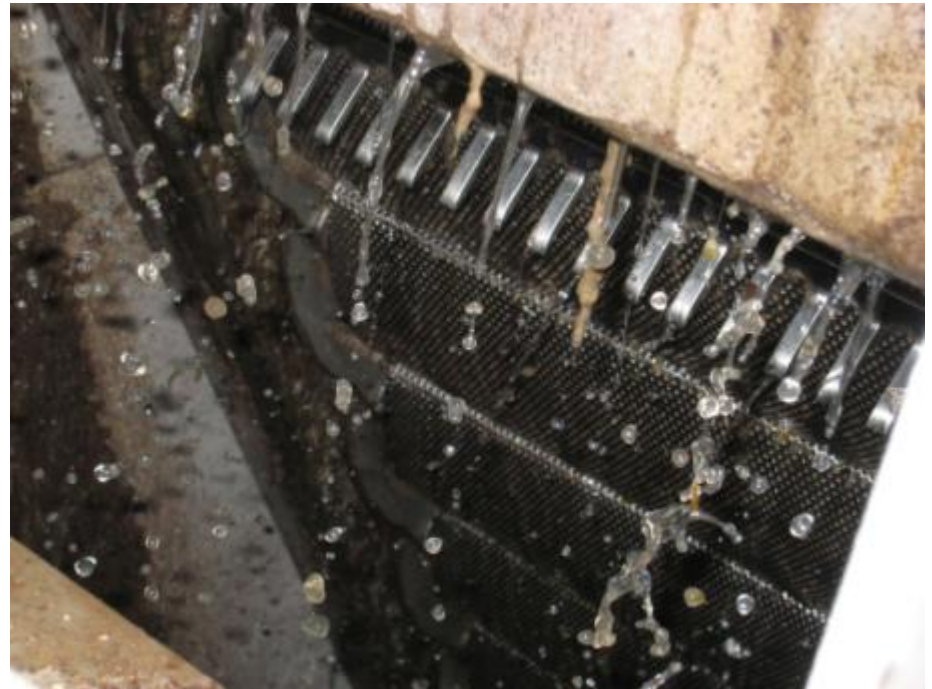
**Debris Carryover From Brush  
and Water Spray**

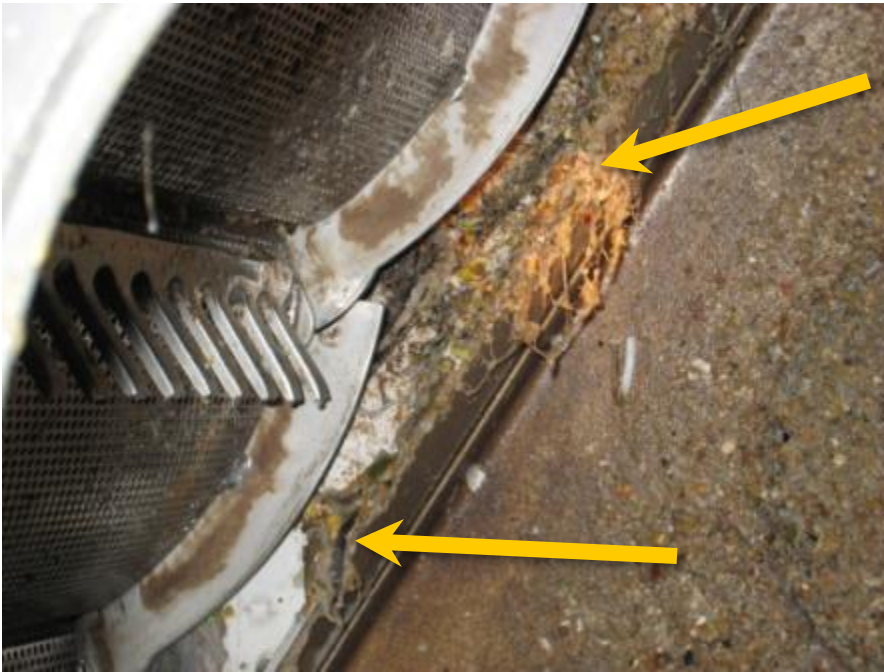
# Debris That Passes Around 3 mm Screen

**Passage Around Edges  
of Plates and Frame**

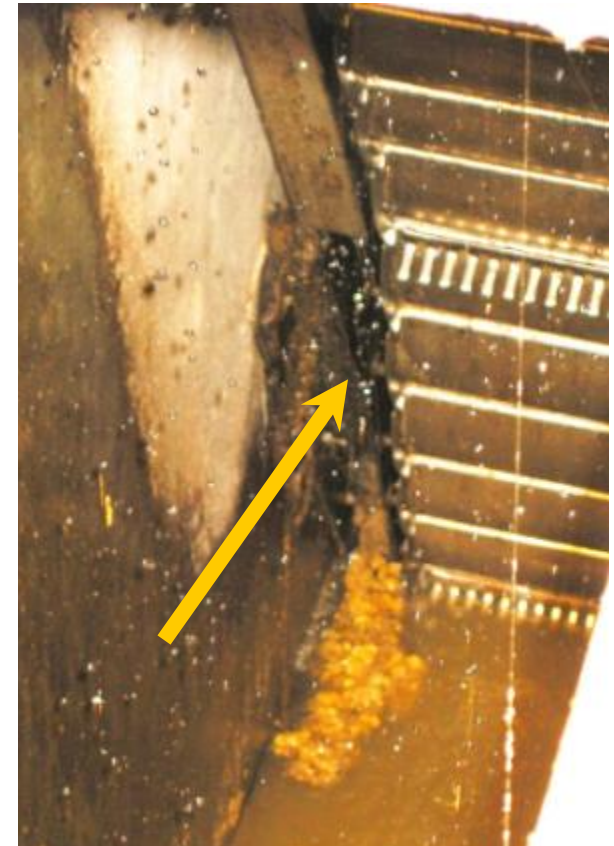
**Contractor Forgot To  
Completely Grout between  
Frame and Channel**

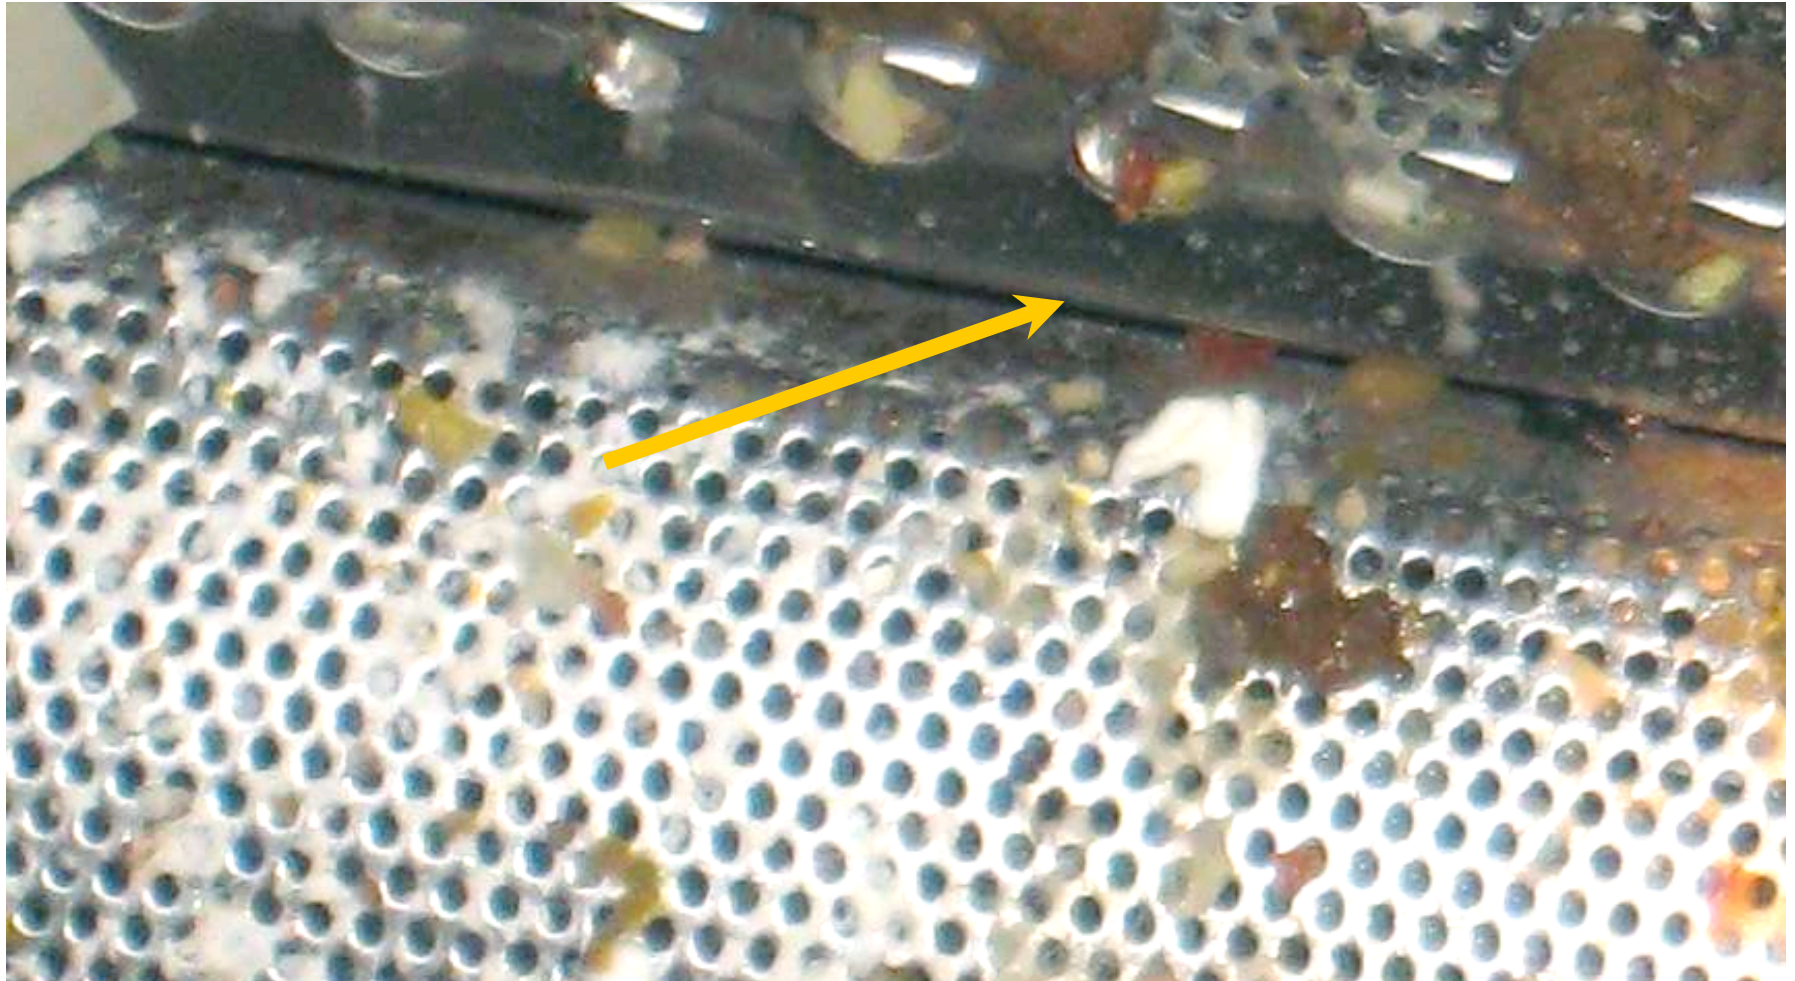
# Gaps Between Plates

**Gaps between perforated plate panels**

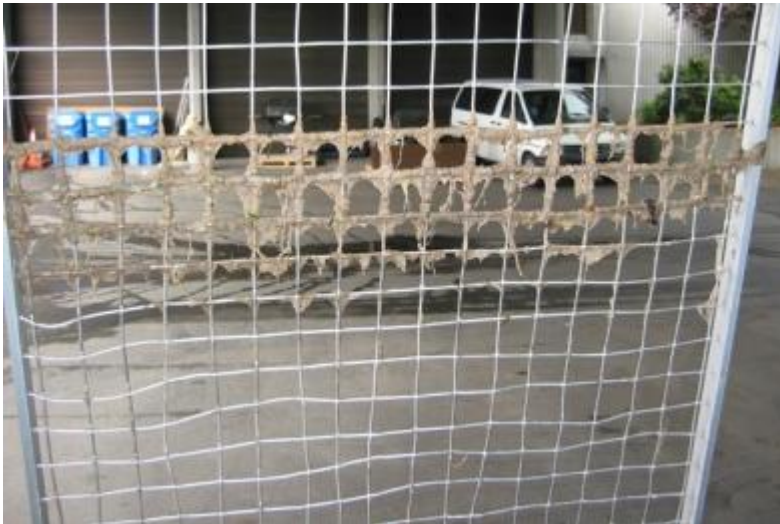
# How Much Debris Really Gets By The 3 mm Screen

**After 2 hours in the  
Screened Sewage**

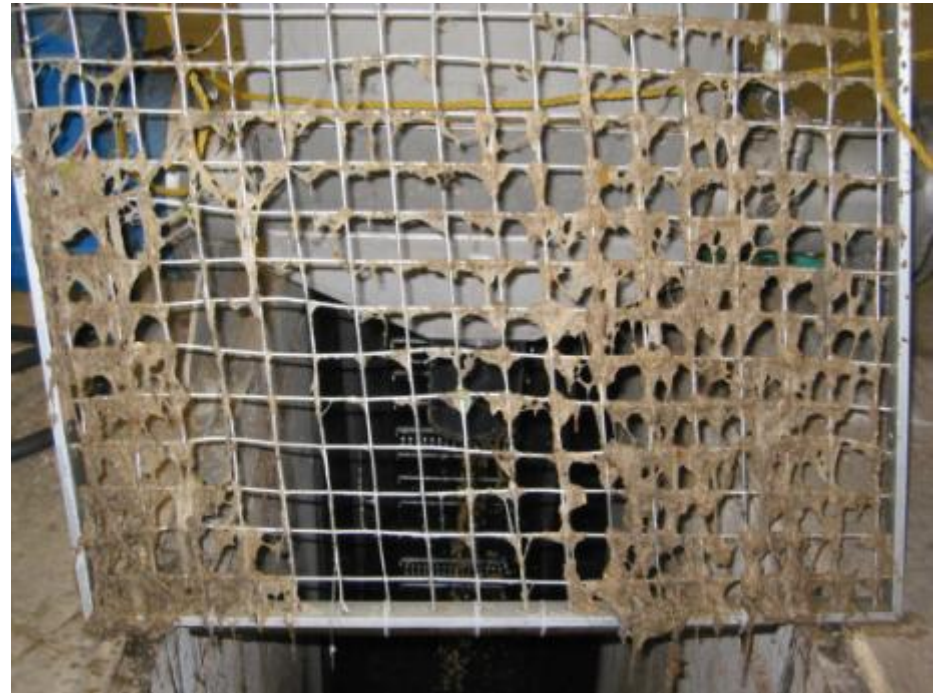
**After 18 hours in the  
Screened Sewage**

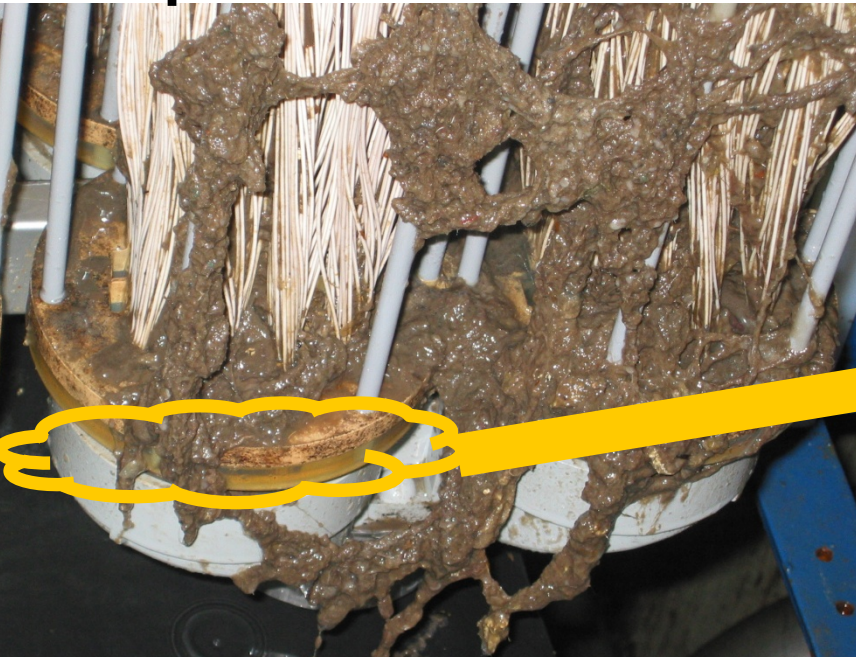
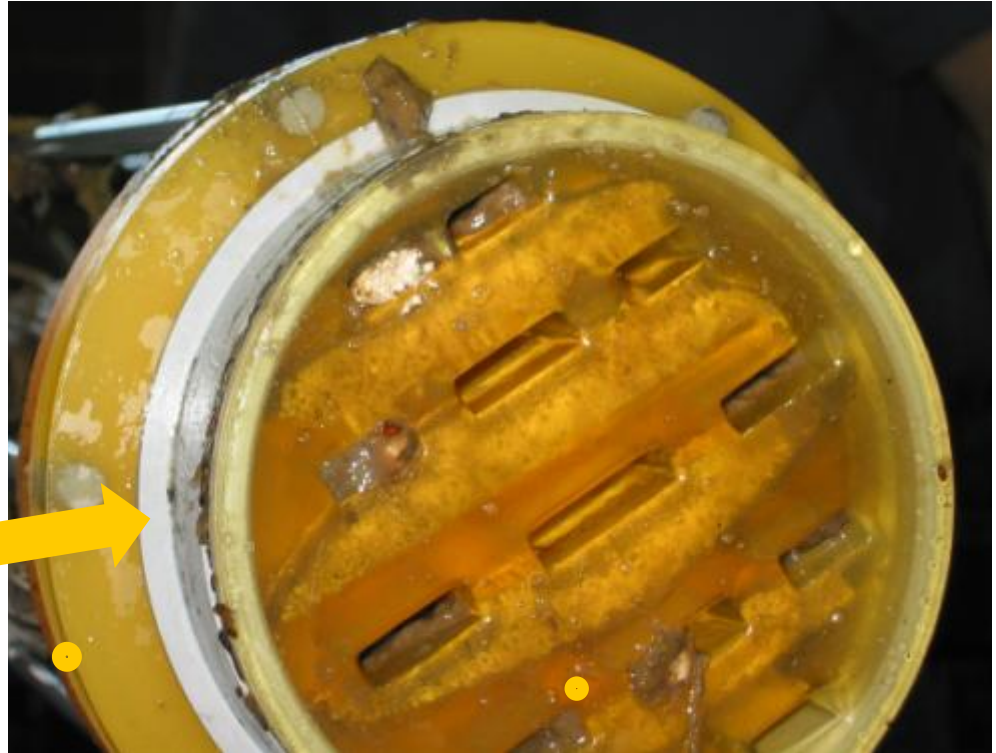
# Fouled Membrane Modules

**Top of Membrane Clover**

**Rack End of Module**

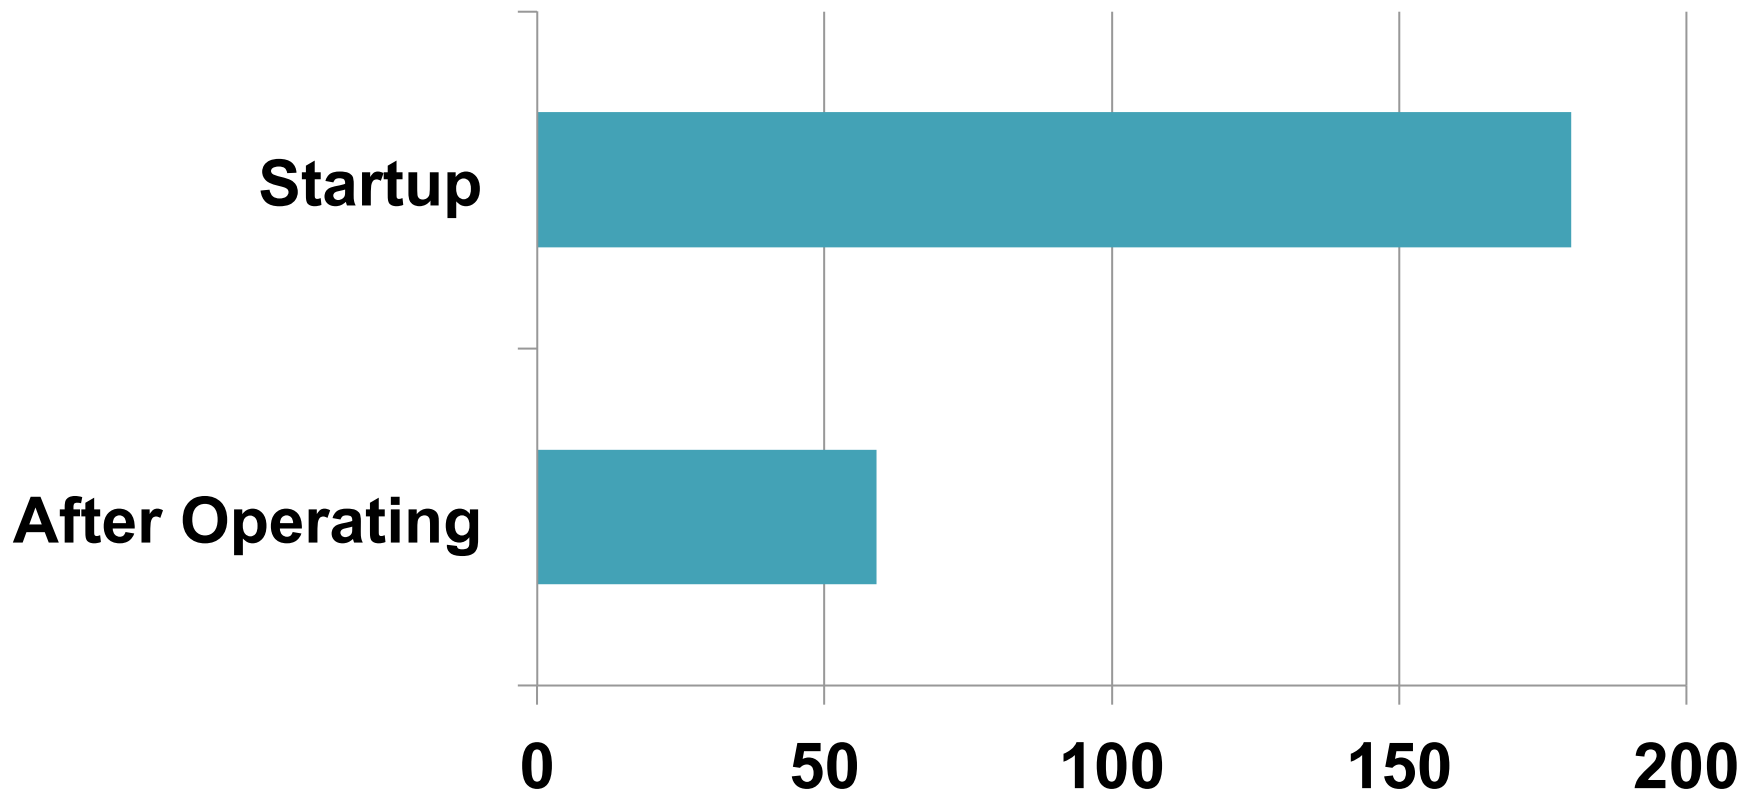
# Loss of Performance

## Membrane Permeability lmh/bar

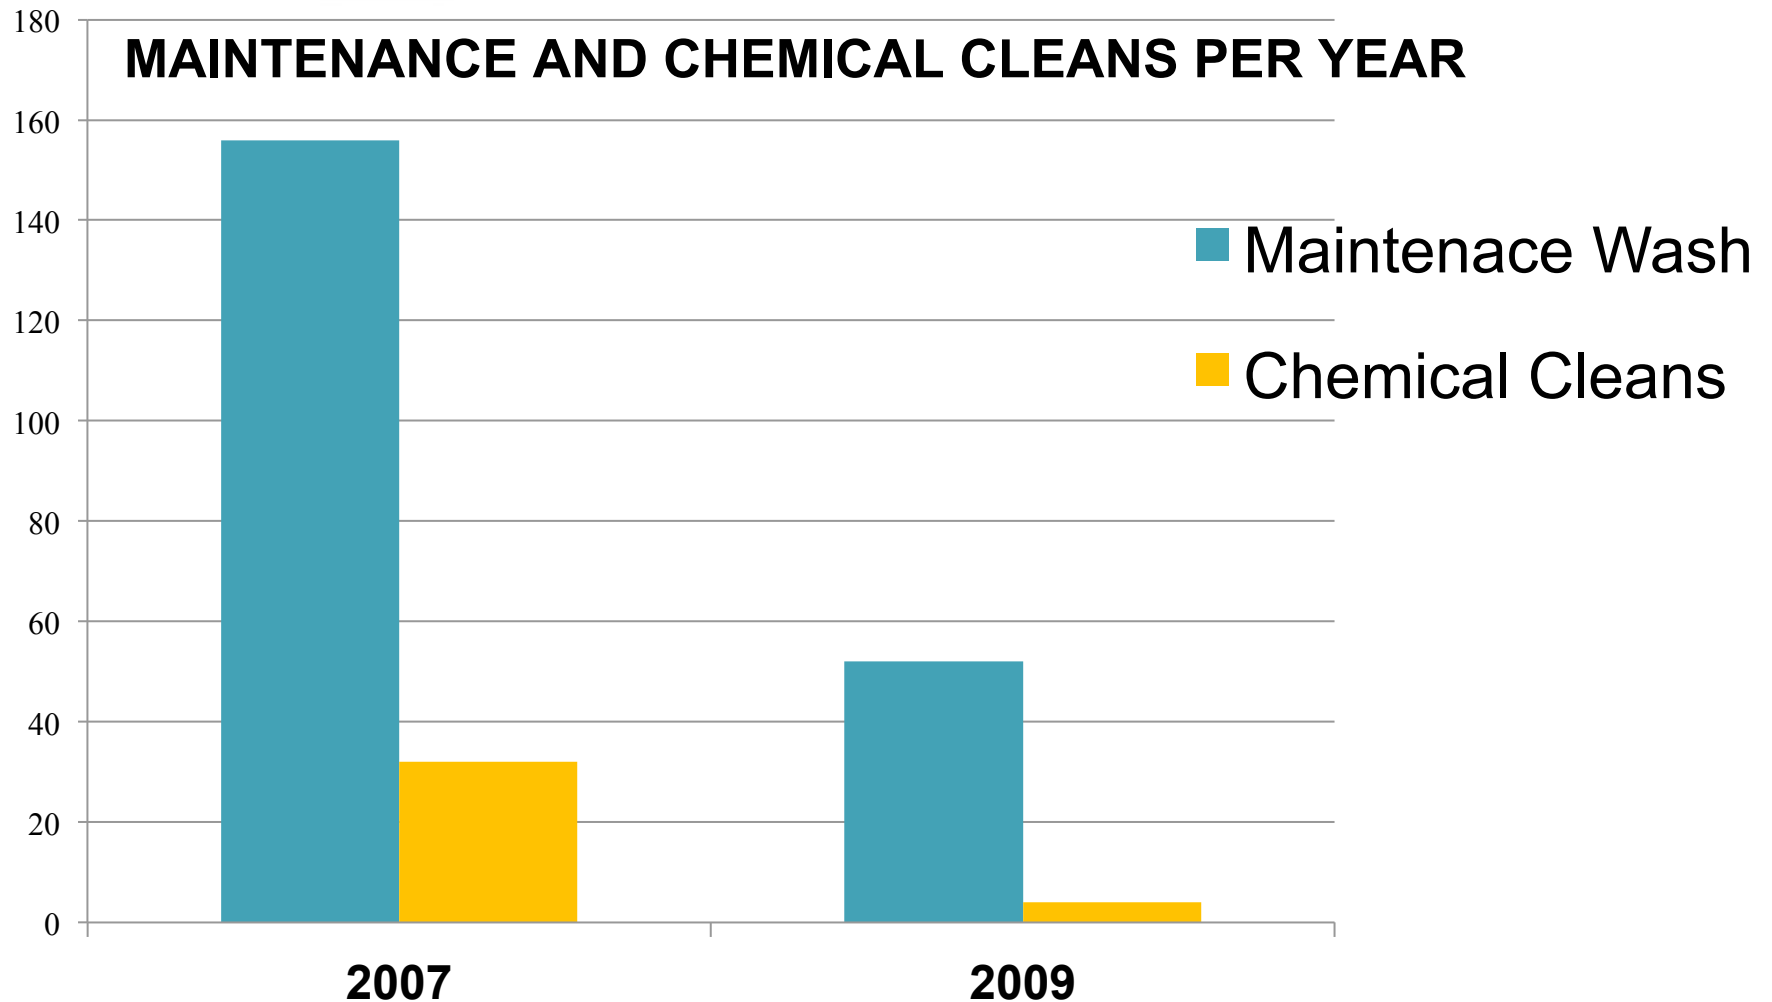
# Excessive CIP's

## *Screen Operational July 2008*

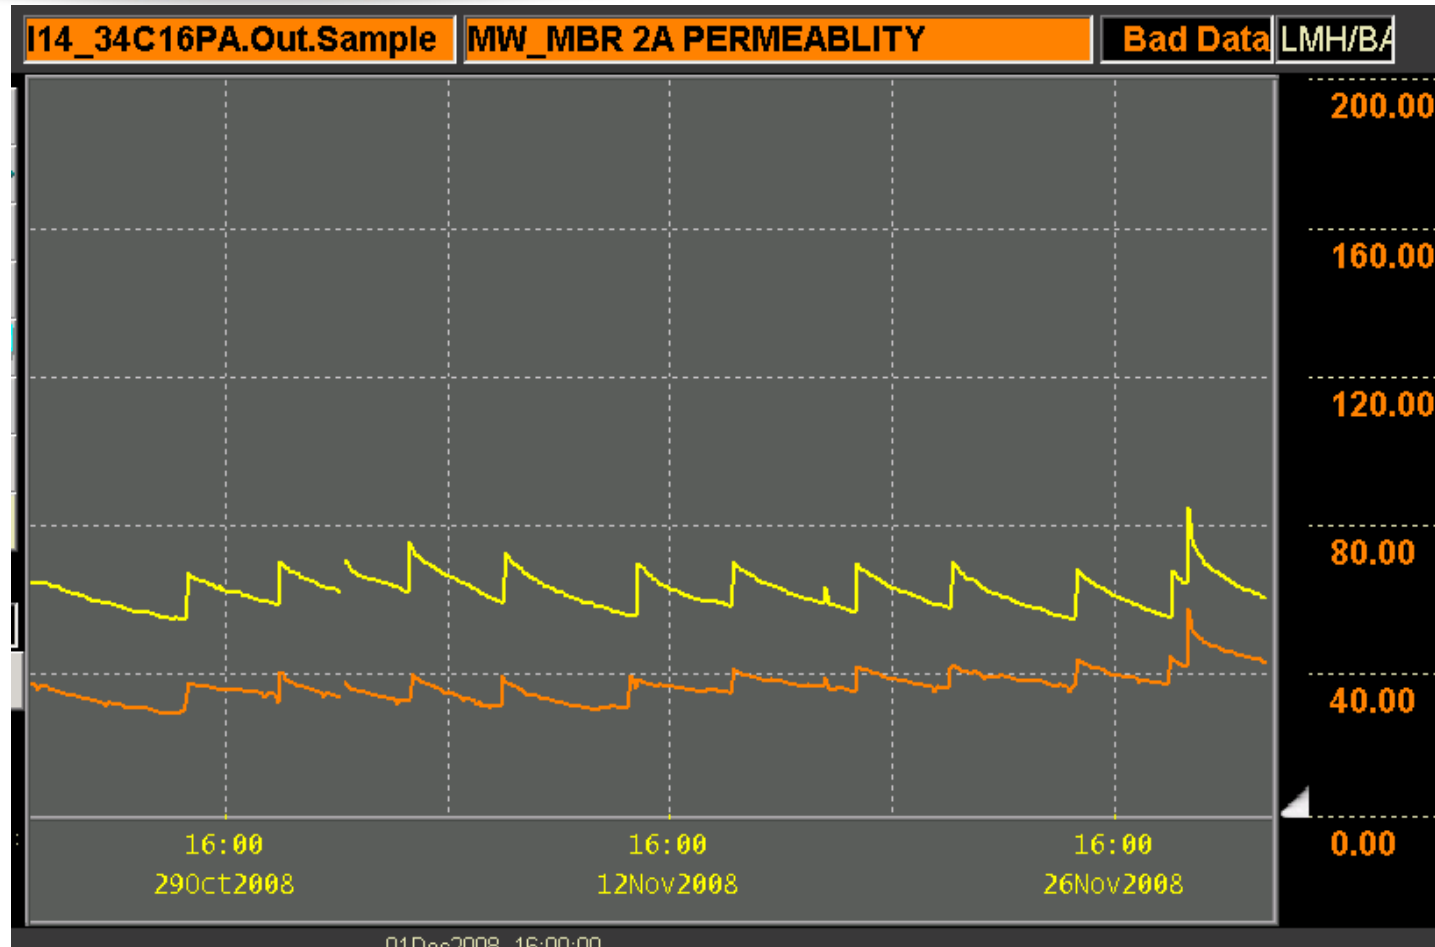
# Loss of Permeability and Increased CIP's due to Fouling

- Maintenance washes 2-3 times per week
- After new screen installation, permeability starts to increase

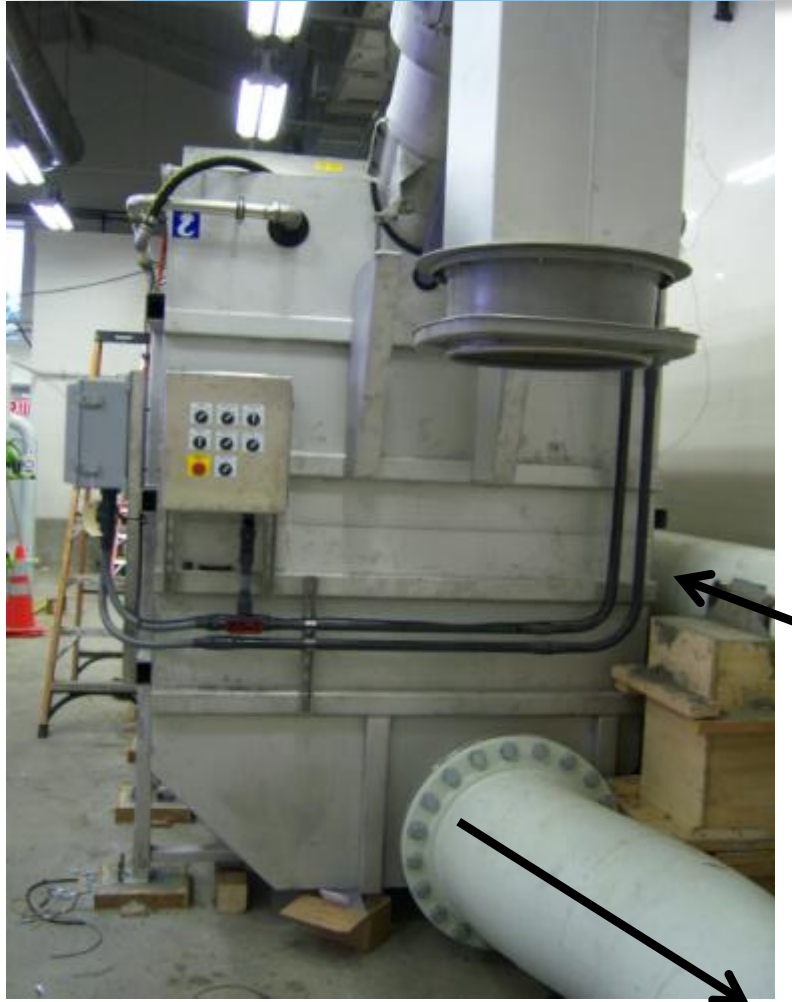
**Screen Effluent**

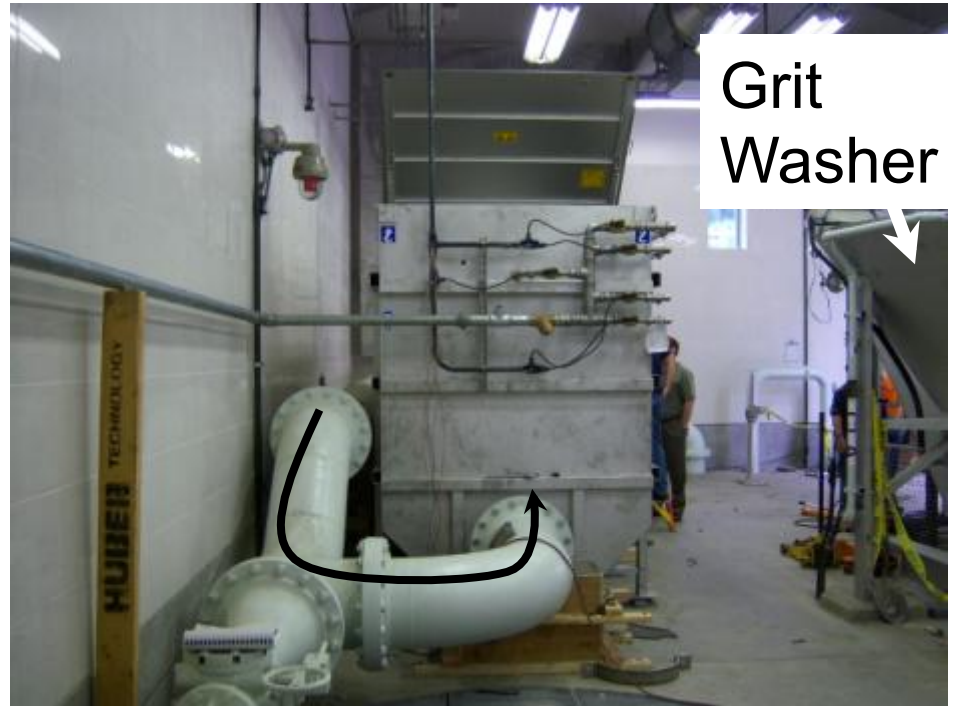
**Screen Influent**

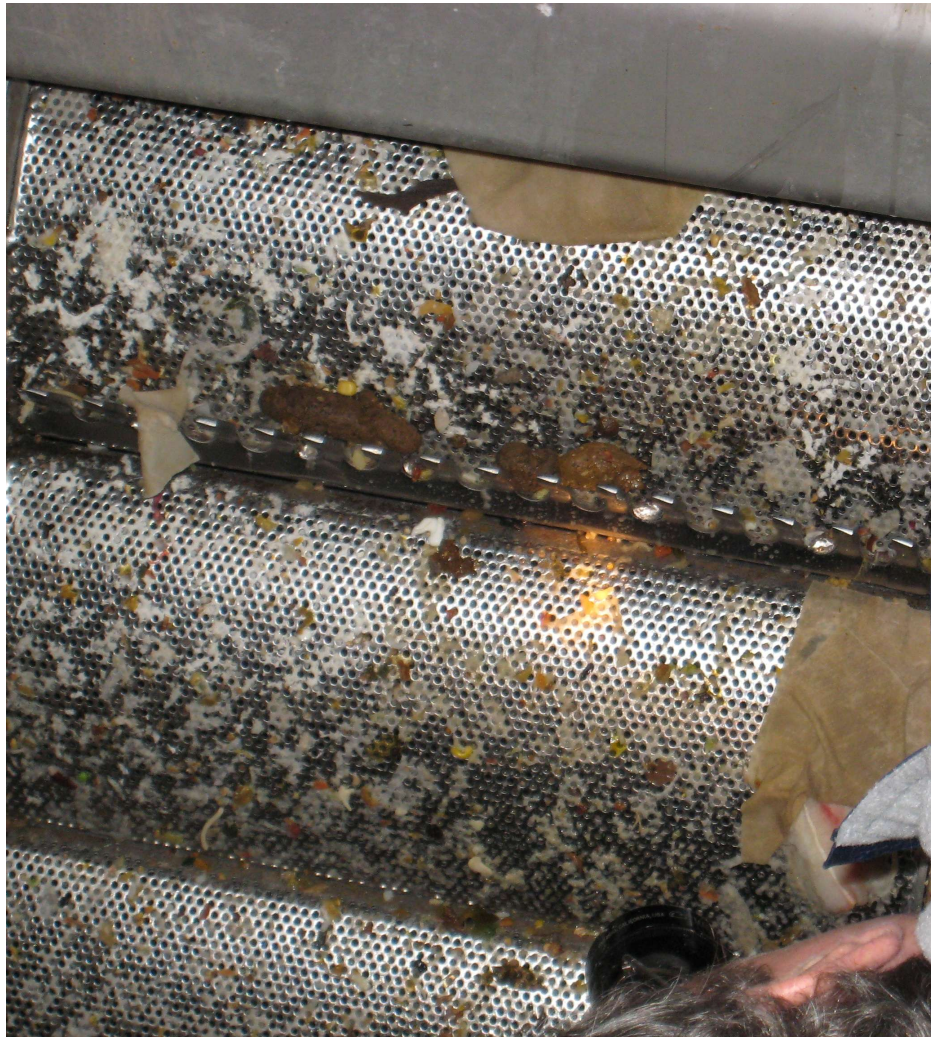
# Fine Screen Removes Additional 1 ½ Yards of Material per Week (<1MGD)

Fall of 2008 - Screened  
Mix Liquor to remove  
Accumulated debris.  
Capture Approximately  
100 cubic yards from  
A-Basins/MBR Tanks

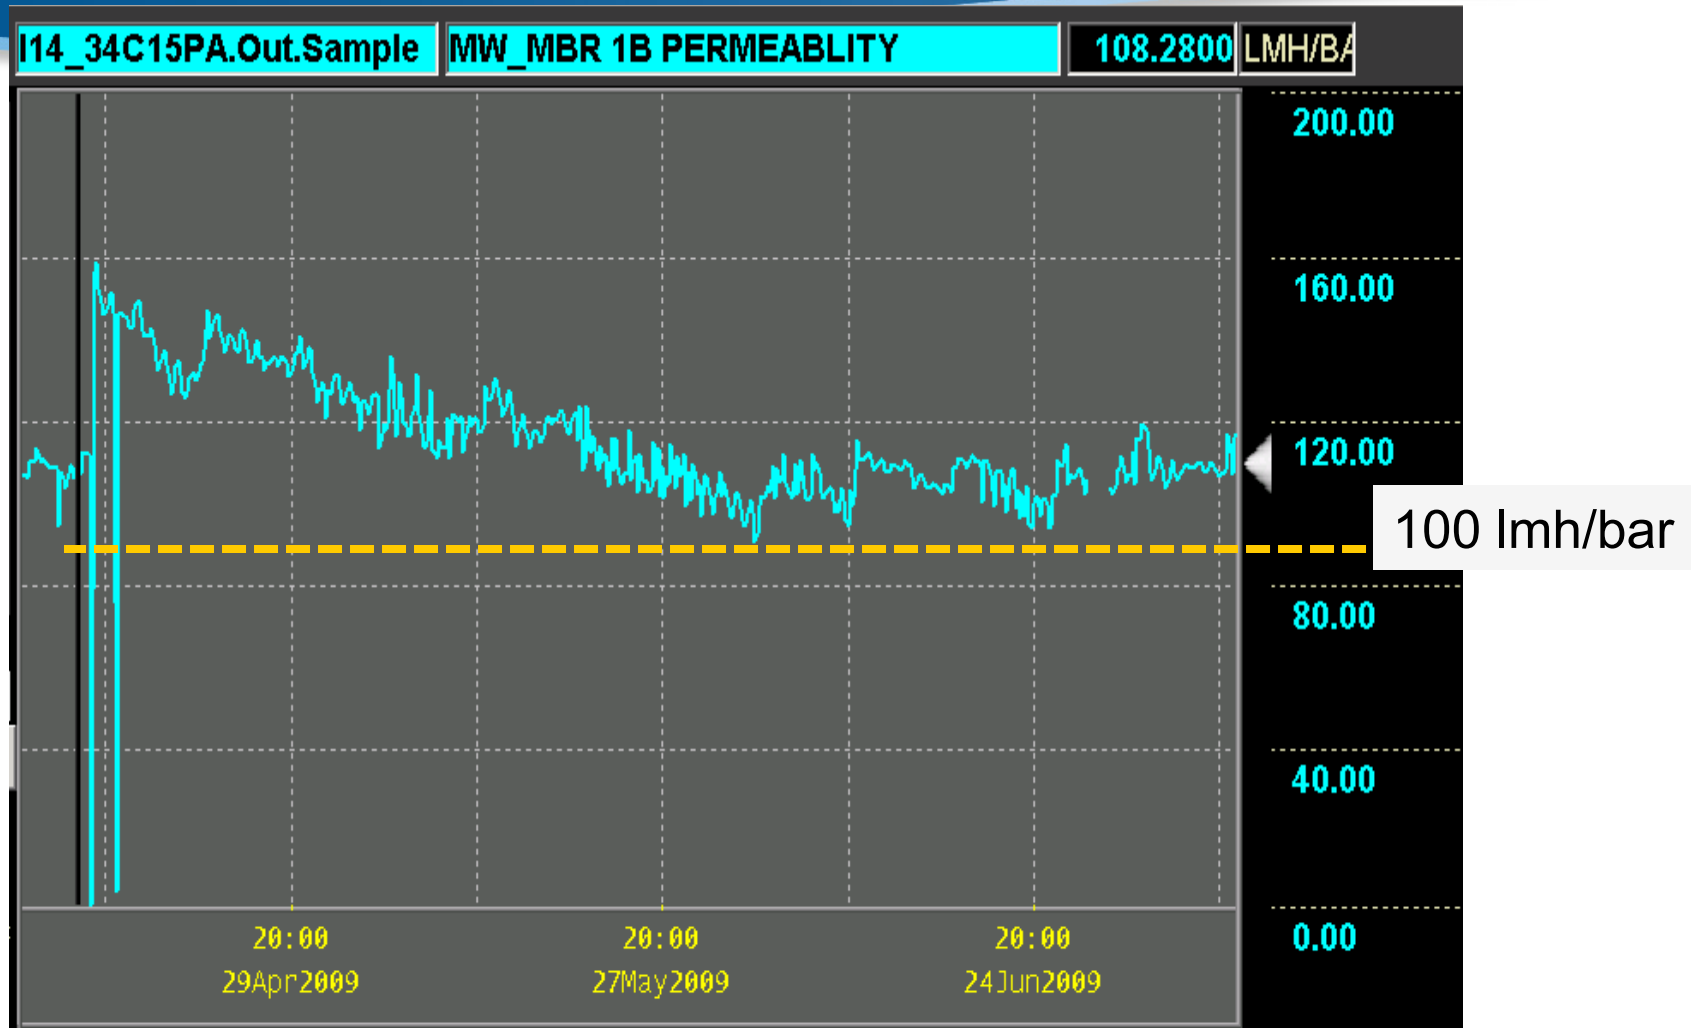
# Results of Membrane Performance After Screen Installation

**Now CIP every 3 months**

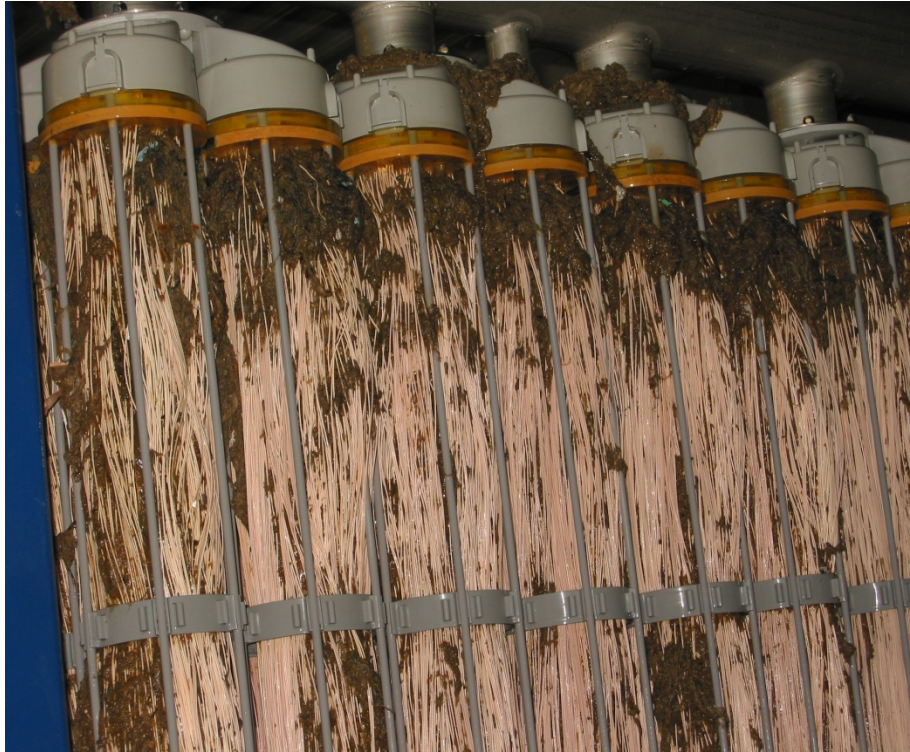
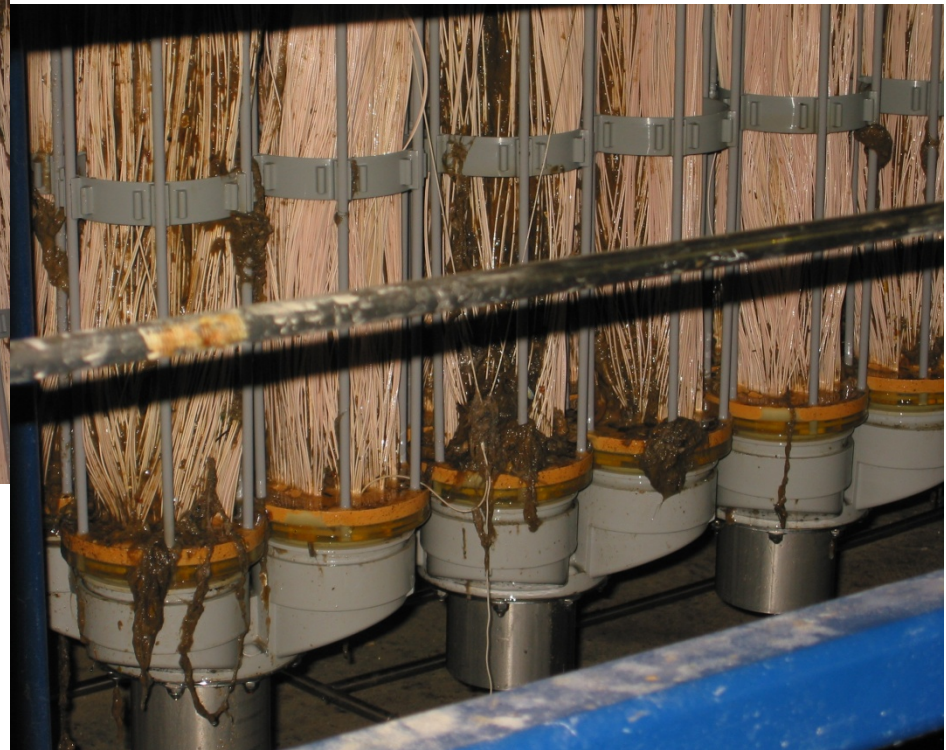
# Comparison of Membrane Modules

Note the accumulation of debris top & bottom and the 'swelling' of the fiber areas

2 years of operation without the 2mm drum screen

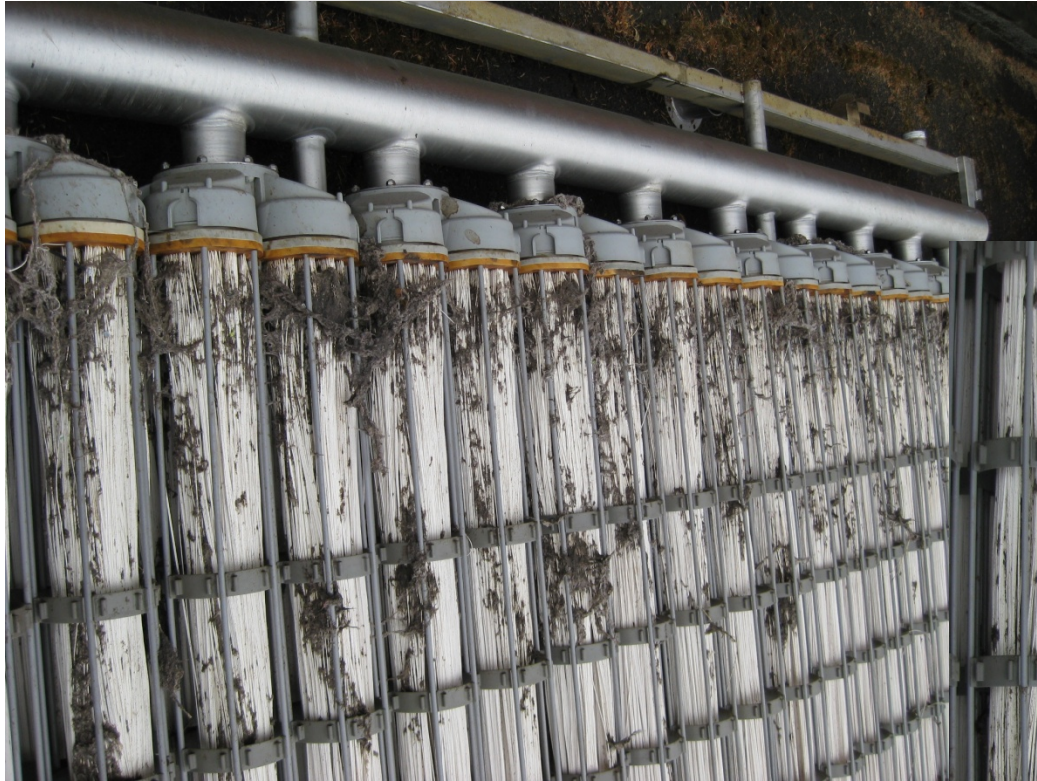
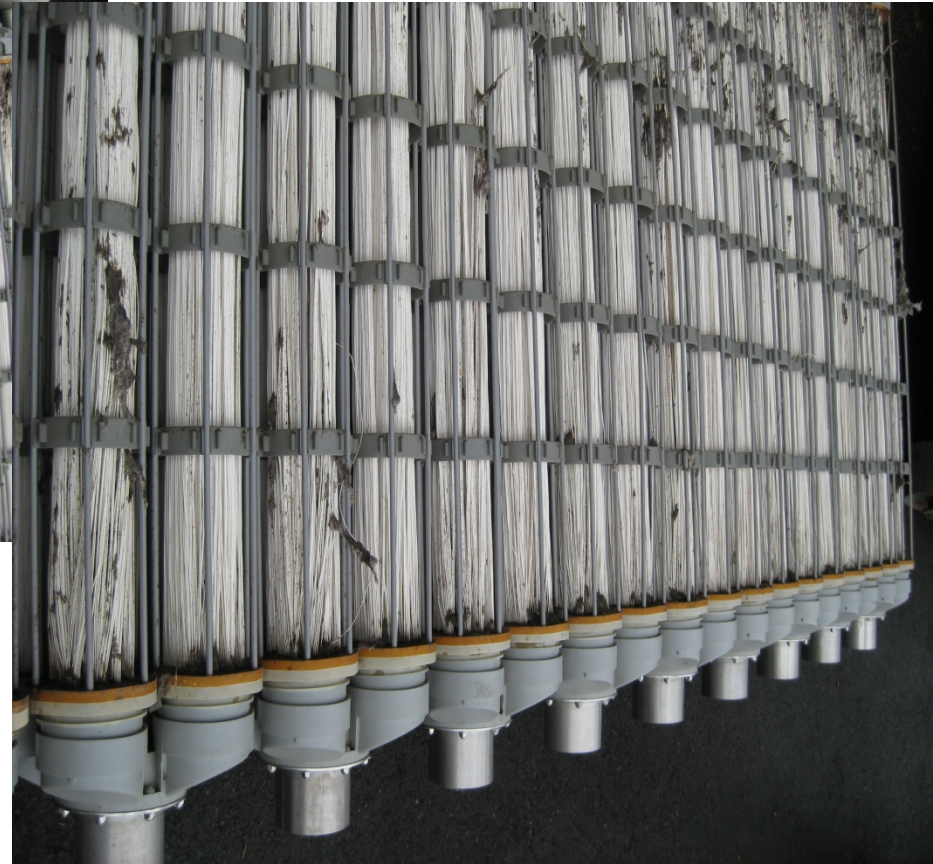
# Comparison of Membrane Modules

4 years of operation train 1  
Post 2mm drum screen

Note the differences in  
debris accumulation

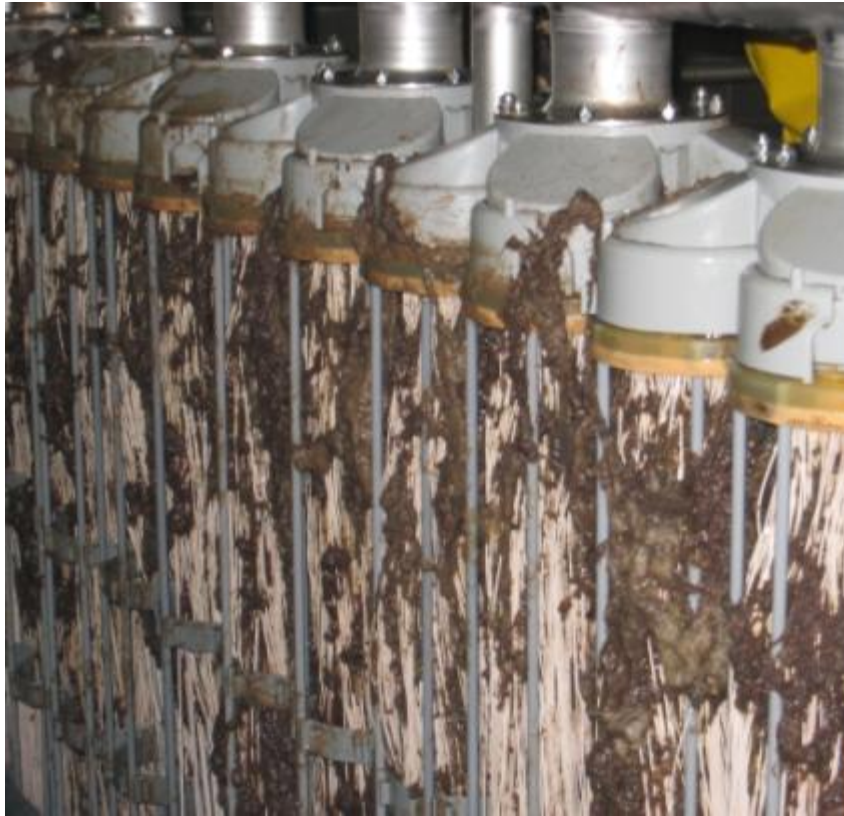
2008

# Comparison of Membrane Modules Treatment Train 2

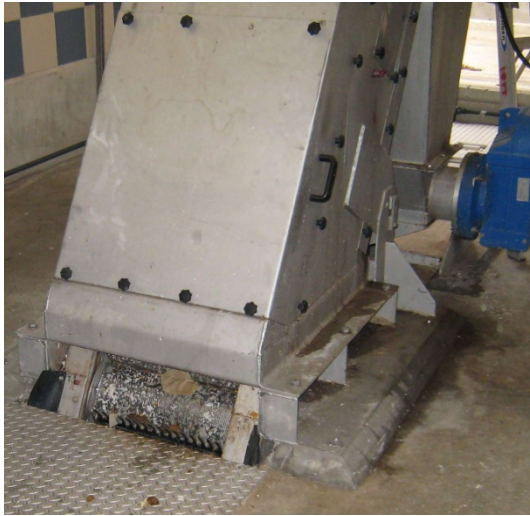
# Not All Screens are Suitable for MBR's

**Perforated Plates**

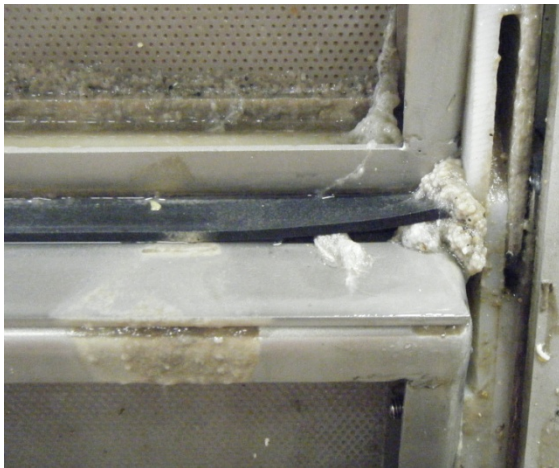
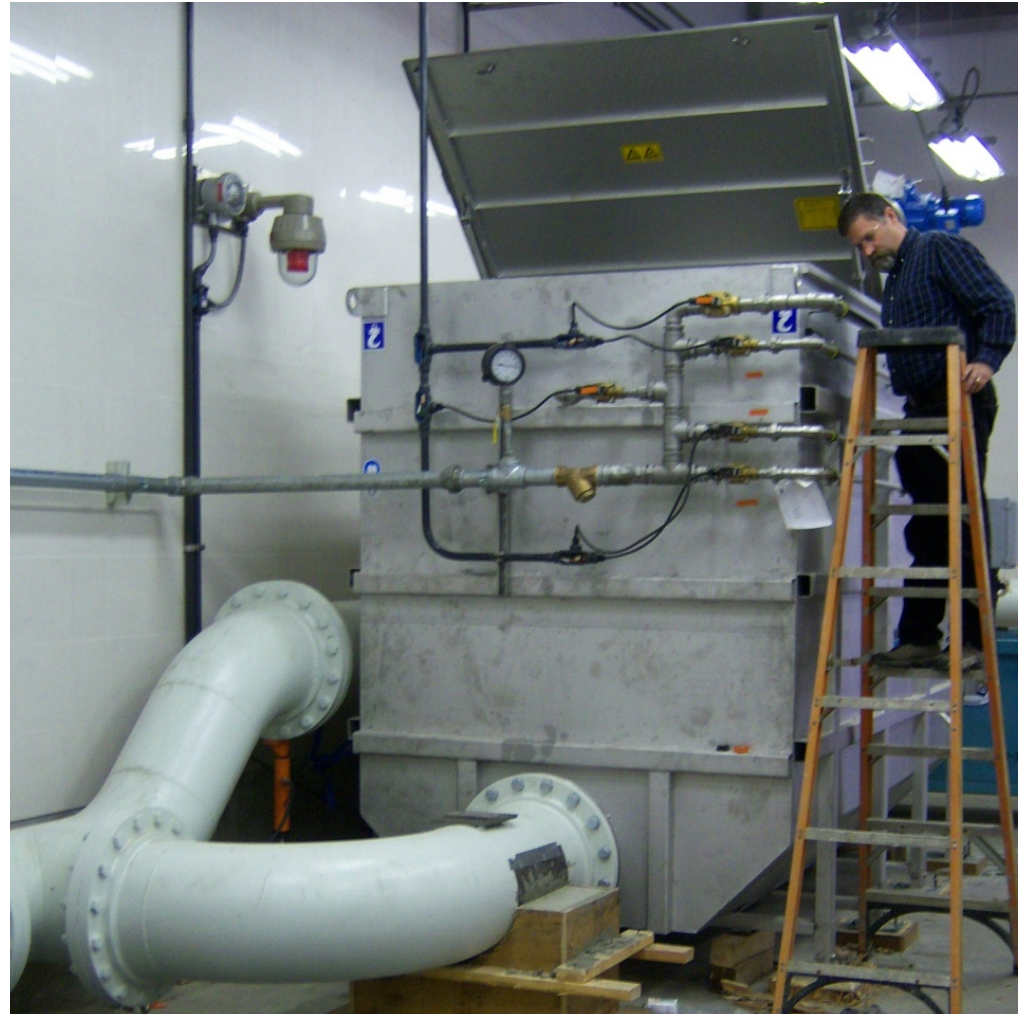
**Basket Screen**
